Kourion Urban Space Project: Preliminary Report of the 2016 Season

Abstract: The 2016 season of the Kourion Urban Space Project (KUSP) focused on the excavation of a structure situated to the southwest of the Earthquake House on the city's acropolis. Excavation revealed a large building, designated Building 4, that had been damaged suddenly and further decayed over time. Though it is uncertain if Building 4 was a domestic structure, administrative facility or both, it is evident from the construction materials, particularly marble and painted plaster wall facing, and imported finds that it served elite members of the Kourion community. This paper provides a preliminary description and analysis of the archaeology of Building 4. It was lodged with the Department of Antiquities, Cyprus, in January 2018 and is published here with the authors' affiliations as they were then.

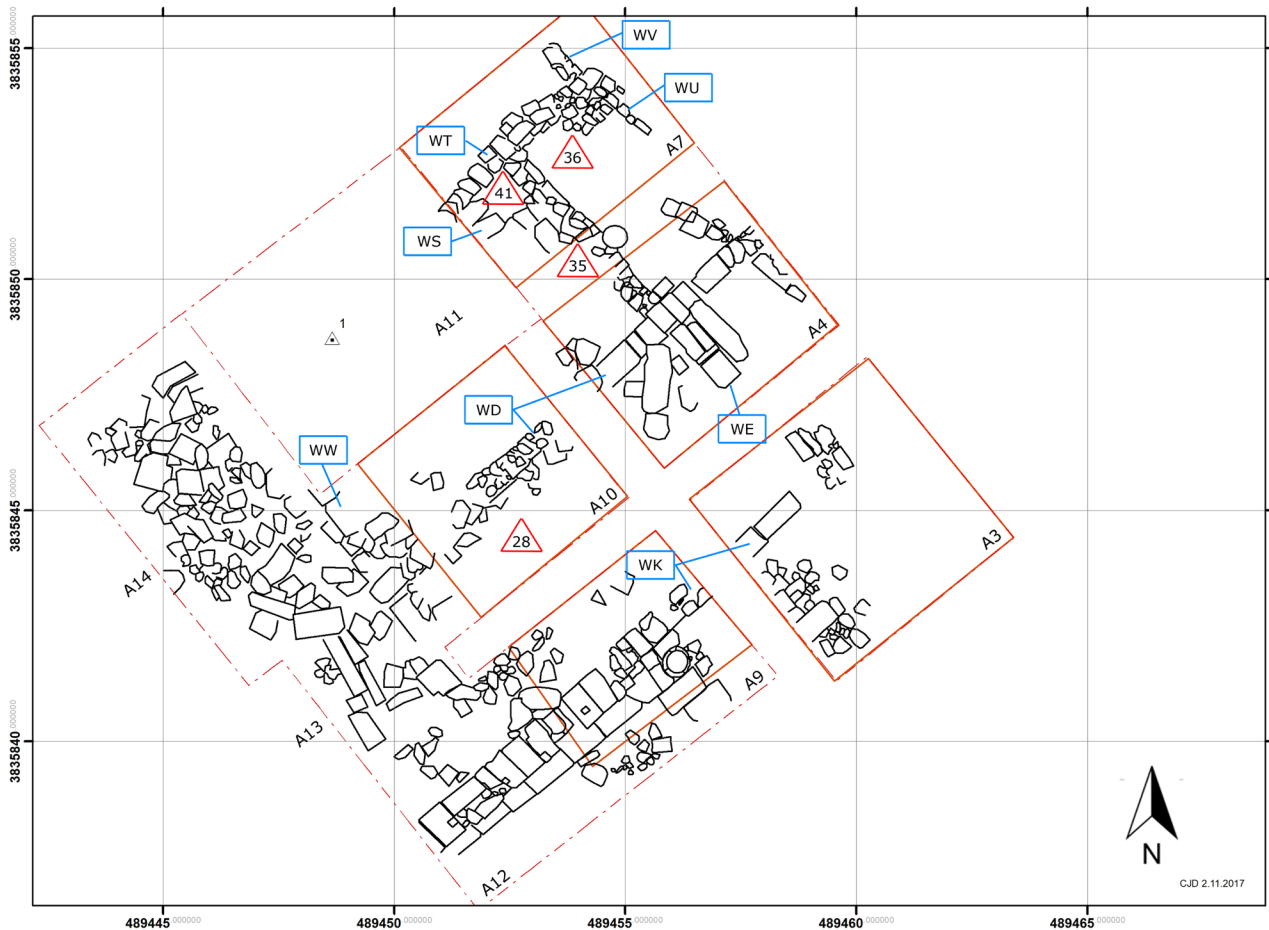
Figure 2: A plan of Building 4. Excavation Unit names begin with the letter A, and Space names are indicated with triangles. Wall names are enclosed in rectangles and begin with the letter W.

The primary aim of the 2016 excavation season was to continue uncovering the remains of Building 4, the large and rich structure that created the mound in this area as it disintegrated (Figure 2). Using the data obtained from this building, along with that from our excavations in this sector of the city, and the Kourion Mapping Project, our overall goal is to examine the diachronic, economic and social changes that took place within this city during the 4th and 5th centuries AD.

Excavation of A7 revealed a complex series of walls (WE, WS, WT, WU, and WV) that enclose at least two known rooms (Space 36, 41). Wall WE, exposed previously in the adjacent excavation unit (A4), extends into A7, nearly bisecting the entire unit. A large wall, WE measures 4.6 m x 0.54 m x 0.49 m and was constructed of irregular cobbles chinked with pottery sherds. At its north-western

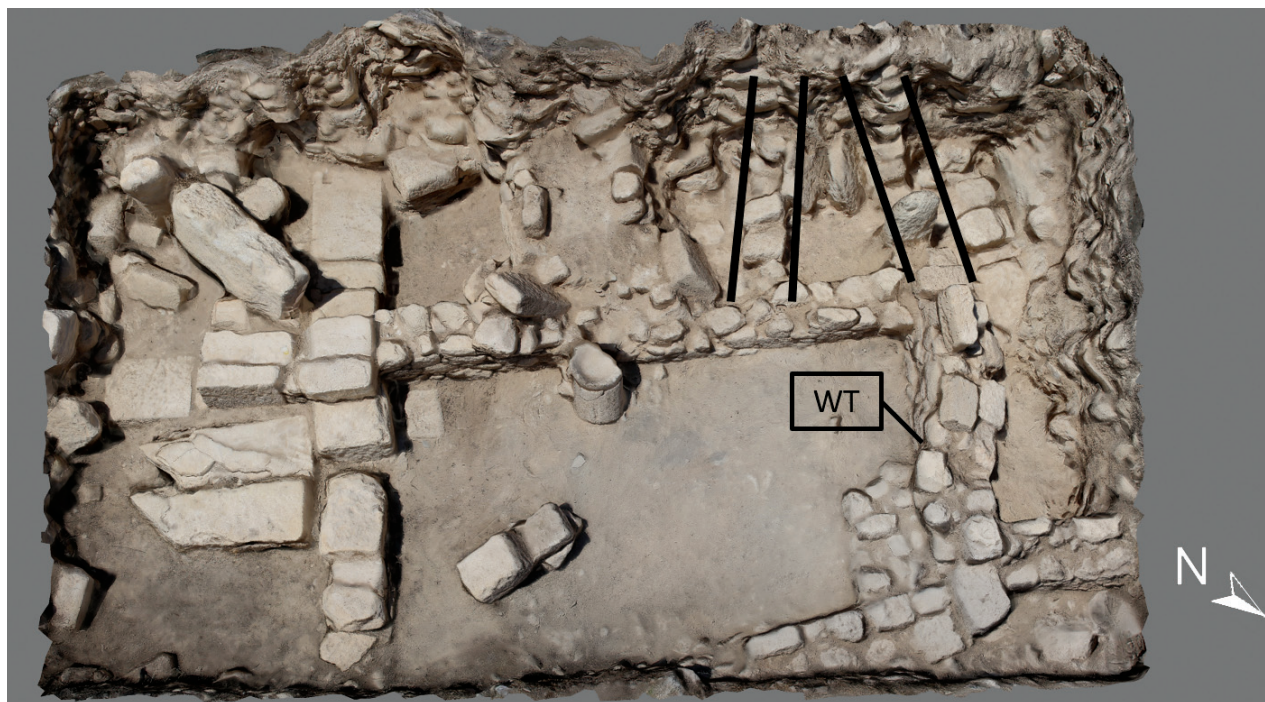
Figure 3: A geo-referenced overhead photograph of the Space 41 corridor. The black lines indicate the walls that border the corridor and may have once contained a stairway.

Space 41, formed by the abutment of WE and WT and further defined to the south by WS, is a narrow corridor. Within Space 41, three upright piers were found, suggesting that this area may have once contained a stairway (Figure 3). The height of the mound formed by Building 4, the large amount of tumbled wall stones and the presence of material culture not used as wall chinking within Stratum 1 strongly support the notion that this structure had multiple stories that required a stairway to access.

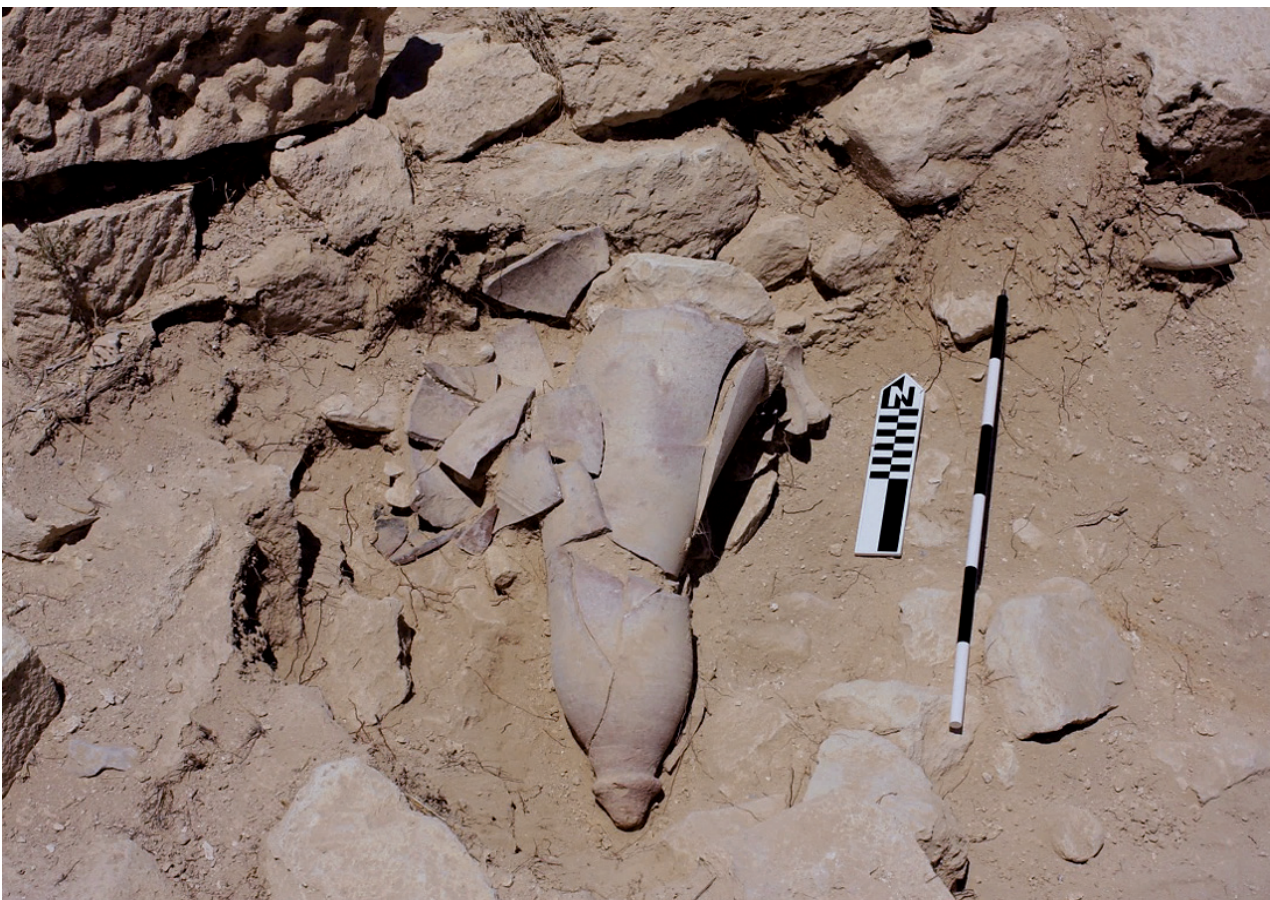
Figure 4: An Egyptian amphora, Egloff form 172 in the Kellia typology, in situ in Space 36, Building 4.

faunal remains, a near complete Egyptian amphora Egloff form 172 in the Kellia typology (Egloff 1977; Figure 4), fragmentary cooking vessels, lamp fragments, a nearly complete glass unguentarium, and three small copper-alloy coins: two illegible, and one with the Emperor Valens depicted on the obverse.

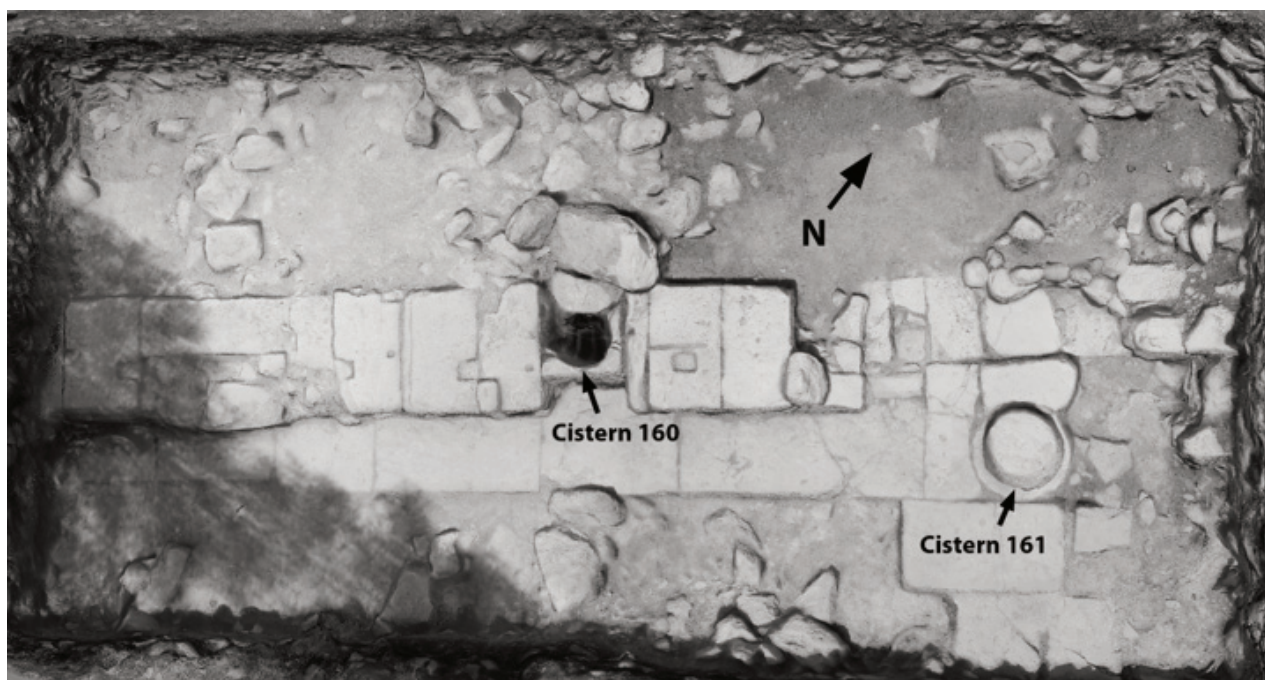
Figure 5: An overhead photograph of Units A9 and A12. There are two co-joined cisterns 160 and 161; Cistern 161 opens into a pavement and is still capped by a cylindrical stone; Cistern 160 is situated within Wall WK and had a rectangular cover that had been dislodged leaving the cistern open allowing it to be partially filled.

in 2016 with the continued excavation of Unit A3, a 1m southern extension of A9, and the opening of A12 (Figure 5).

The full length of WK is still unknown, but the northern terminus was found in the southwestern section of A3. The exposed section of WK measures 7 m x 0.5 m and is constructed using square cut limestone blocks that overlay flat cut-rectangular slabs that may have functioned as paving stones. Set within WK is the collar of Cistern 160 in A12 and in the adjacent limestone pavement is the collar of Cistern 161 in A9. These underground

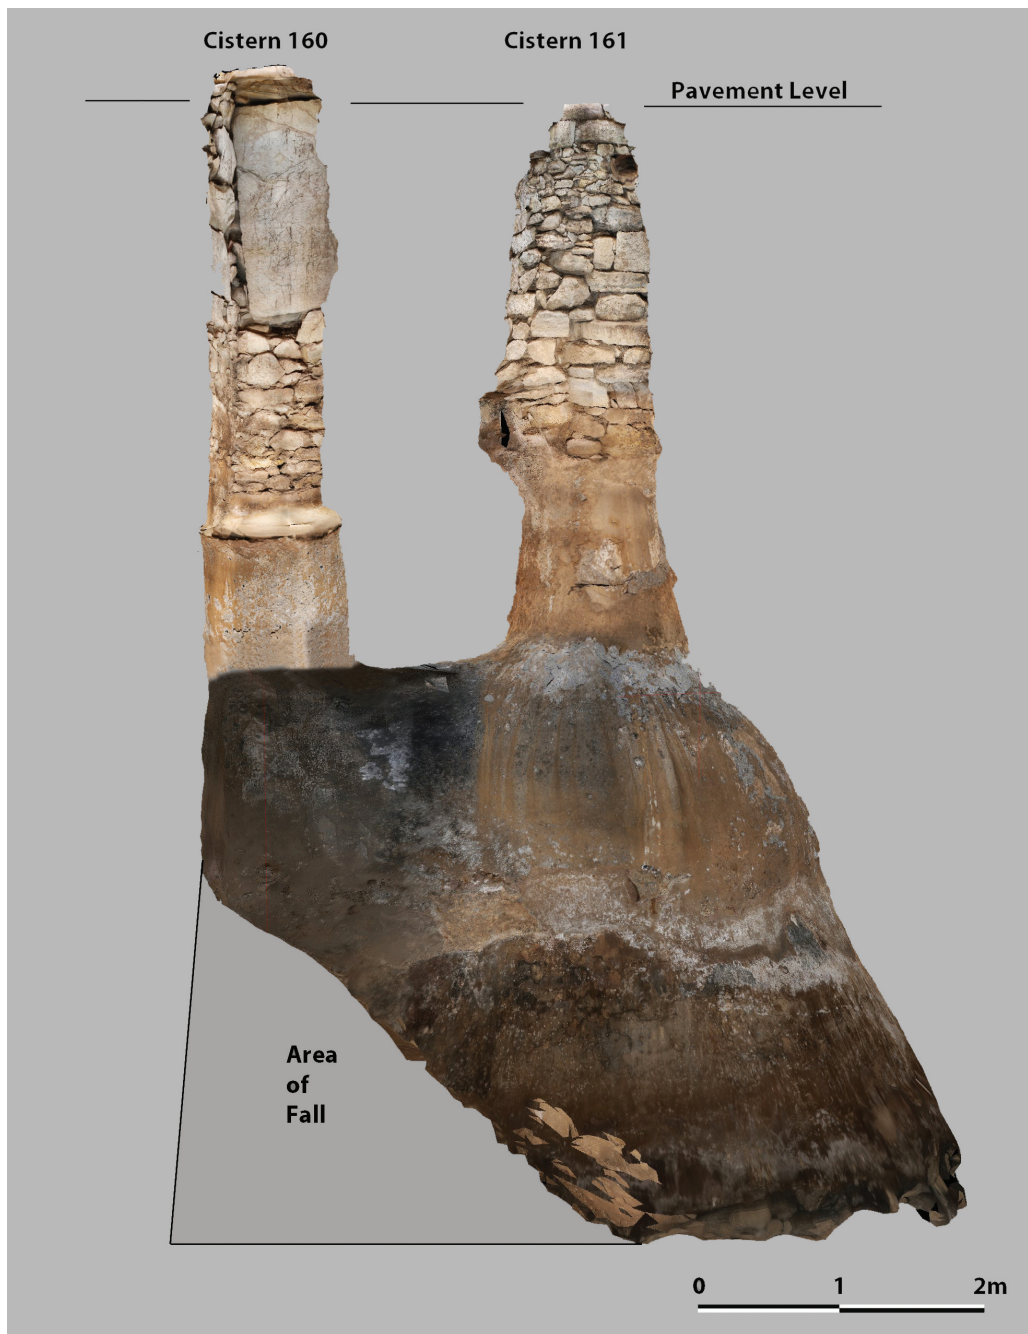
Figure 6: An orthophotograph of a section looking north of the conjoined Cisterns 160 and 161 in Units A9 And A12. These cisterns have separate openings and shafts which lead to a single reservoir.
Image generated by Agisoft Photoscan.

openings have been imaged using a remotely operated camera to produce a 3D image, one projection of which is in Figure 6.

The shaft-collar of Cistern 160 is 0.48 m square and Cistern 161 is 0.42 m diameter. Cistern 161 has a circular cover stone in situ while Cistern 160's rectangular cover was dislodged leaving the cistern open. Cistern 160 has niches in the stones adjacent to the collar that may have secured the axel of a windlass. The two shafts lead to the same underground reservoir in which there is a heap of rubble and soil the top of which is under the shaft of

Cistern 160. It is probable that the cistern was operating when Building 4 was abandoned and that the debris entered the cistern subsequently through Cistern 160, which had been left open. The shaft of each cistern has a similar design and construction. Below the collars are dry-stone lined 0.8 m square shafts down to the bedrock, which is 2-3 m below the surface. The shafts continue through the bedrock at about 1 m diameter into to the reservoir, the top of which is about 4 m below the surface. The reservoir of Cistern 161 is a rock-cut bell-shaped void with a base measuring 5-6 m diameter about the shaft centreline 8 m below the collar. This reservoir was extended westward to meet Cistern 160. Cistern 161 has a 0.2 m diameter pipe entering it about 1 m from the surface. The fall of the pipe is yet to be measured but it is most likely toward the cistern as there is no other means to fill it. Cisterns 160 and 161 were structurally integral to Building 4 and, together with the network of pipes and drains that filled these cisterns, were constructed contemporaneously with the surface structures.

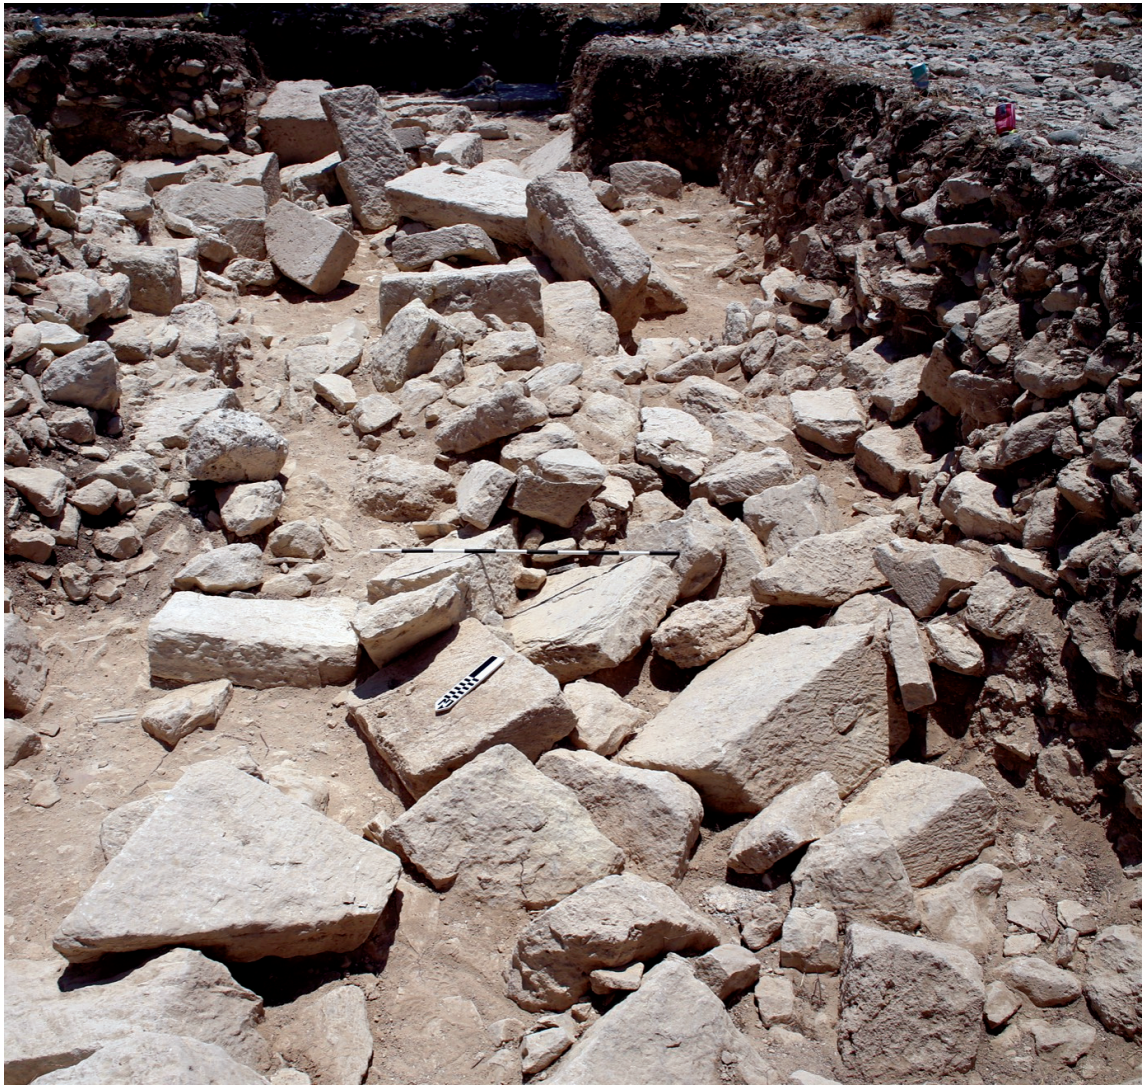
Figure 7: Tumbled wall stones found across Units A13 and A14. The majority of the wall stones found in these units were large, shaped limestone blocks. A high concentration of broken roof tiles was also found in these units.

Two new excavation units were established in 2016 along the southwest side of the mound, Units A13 and 14. Both units contained a large concentration of tumbled wall stones and broken roof tiles, and appear to represent the same space within Building 4, as no bisecting wall was found (Figure 7).
